Chassis ID: 8 992520 VIN: YV2XTW0A3S8992520 Work Order: 7764

FCIOM-C109315: Active
Occurrences: 3

FCIOM – Front Chassis I/O Module**C1093** – Windscreen Washer Fluid Pump Circuit**15** – Circuit Short To Battery or Open

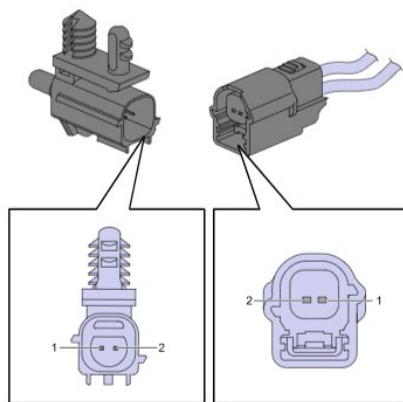
1 Connector check:

- Check that the connectors are properly connected and locked into position
- Disconnect and check the component connector
- Inspect pins and terminals for oxidations or corrosion
- Ensure that the pins and terminals are locked into the connectors and that they are not pushed back out of the sockets
- Check the pins and terminal are not damaged (which can cause poor connection)

After completed procedure, reconnect all connectors

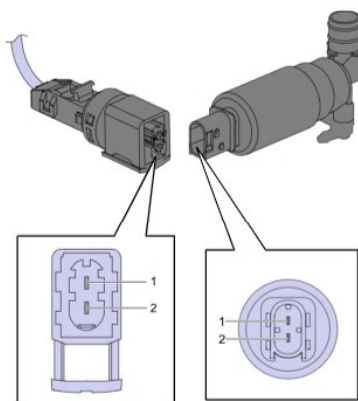
Connector		Tool pin	Target values	Entered value
Function	Pin			
Control wire	M02:2	+ 60 (D)	2.5-6.0Ω [1]	<input type="text" value="0"/> Ω
Ground	M02:1	- 59 (D)

[1] Resistance check

recommendation is to disconnect the component connector and refresh DTCs. Use Repair verification procedure to refresh DTC read out. If the DTC become inactive the fault is in the component

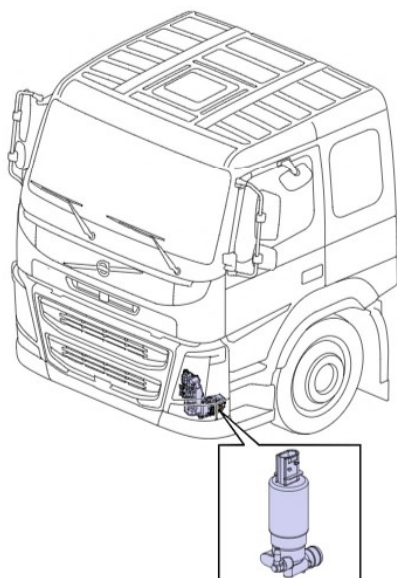
Component location

- ▼ 1 Wiring harness ✓
- ▲ 2 Windscreen Washer Fluid Pump (M02) ✗
 - ▼ 1 Connector check ✓
 - ▼ 2 Electrical test ✗
- ▼ 3 FCIOM (Front Chassis Input Output Module) (A1... ?

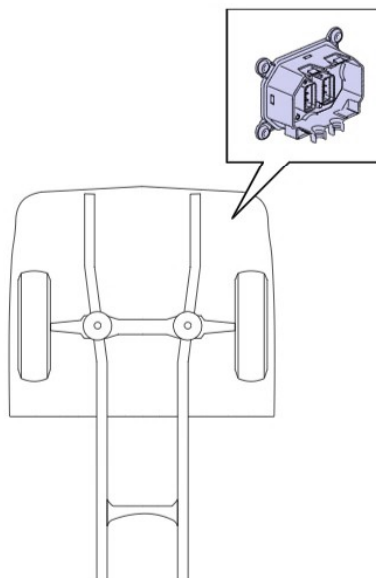
Component location

▼ 1 Wiring harness ✓

▼ 2 Windscreen Washer Fluid Pump (M02) -

^ 3 FCIOM (Front Chassis Input Output Module) (A1...) ✓

▼ Connector check: A162.X2 ✓
