Chassis ID: 8 992520 VIN: YV2XTW0A3S8992520 Work Order: 7764

FCIOM-C109315: Active
Occurrences: 3

FCIOM – Front Chassis I/O Module**C1093** – Windscreen Washer Fluid Pump Circuit**15** – Circuit Short To Battery or Open

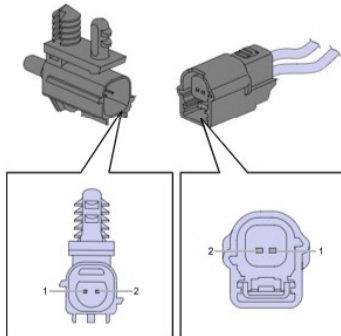
Connector:

- Higher voltage than normal
- The voltage at pin X2:7 is above normal value

Wiring harness, Damaged connector

- Check that the connectors are properly connected and locked into position
- Disconnect and check the component connector
- Inspect pins and terminals for oxidations or corrosion
- Ensure that the pins and terminals are locked into the connectors and that they are not pushed back out of the sockets
- Check the pins and terminal are not damaged (which can cause poor connection)
